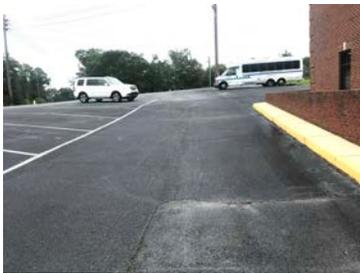
#### View of outside of the administrative offices in CLC

- Install barricade system
- Remove asphalt, concrete, and debris
- Install an engineered trench system using track excavators and compactors
- Install a foundation drainage system per design
- Waterproof with two coats of emulsion over glass fabric

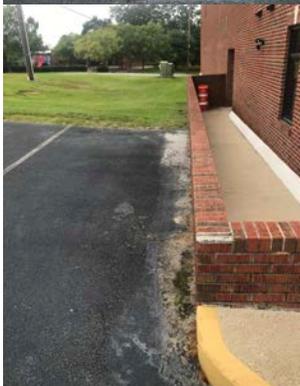
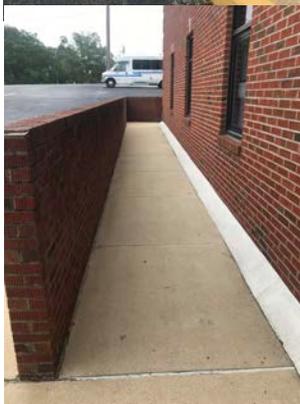
Professionals with Gordy Engineering Company and iGreen Solutions Inc, a waterproofing/remediation company, have examined our roof systems and scoped our drain lines below ground. They have discovered old pipes with faulty material and a major section of the main trunk line that is severely misaligned. As a result, water that would ordinarily be carried away through our underground system is now emptying out somewhere underneath the building. In their professional opinion, we are at a critical point with water intrusions below the building. If not addressed soon, the water will begin to affect the structural integrity of the building.

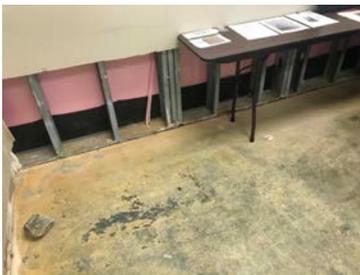
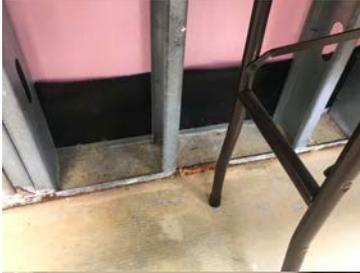
### **Interior views of the water damage to the CLC admin offices**

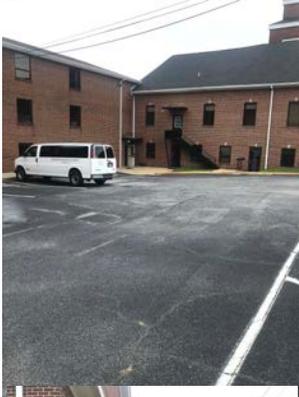
#### **Side view of front of Peacock Hall**

- Waterproof with installation of sheet membrane, dimple mat
- Install foundation drainage system

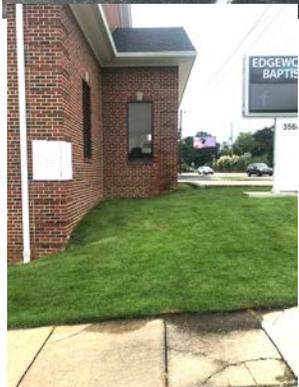
#### **View facing Education Center**

- Install engineered trench system
- Replace concrete, finish in place
- Replace sod

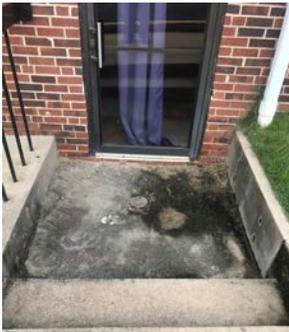
### View of side door of basement of Peacock Hall

- R&R window well cover
- Reinstall drainage system

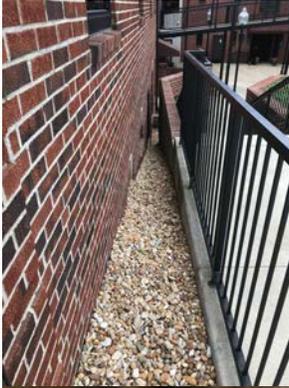
### View of west side of Peacock Hall at entrance of Howle Terrace

- Repair drainage system

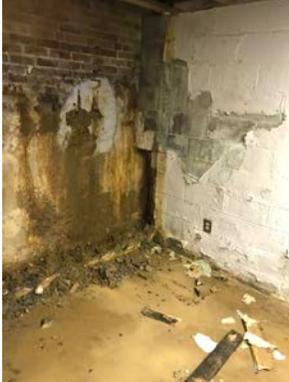
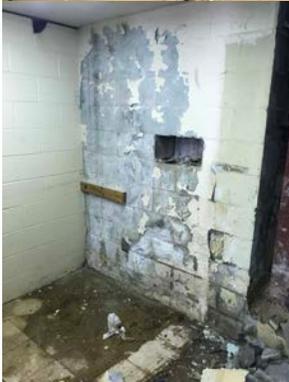
For some time now we have had a problem with water seeping out through a wall in a large storage room adjacent to Fellowship Hall and below the Education Center [our "vintage" members would know this room as 001]. The source for some of the water was underground springs that became particularly troublesome when the water table would rise with heavy rains.

#### Views of wall in room 001

With the correct solution in hand, the first goal is to immediately relieve the hydrostatic pressure behind these walls.

- Demolition of concrete wall base, interior framing, and constructed 2x4 wall
- Waterproofing-Sika Plug Epoxy
- Fill repairs in structural wall
- Install rubberized membrane & dimple mat
- Install foundation drainage system, professional French drain, and grate system.
- Install new concrete over interior drain system
- Outfit and install sump pump, basin, and pic drainage system.
